The Preservation and Repair of Historic Log Buildings

Bruce D. Bomberger

U.S. Department of the Interior
National Park Service
Cultural Resources
Preservation Assistance

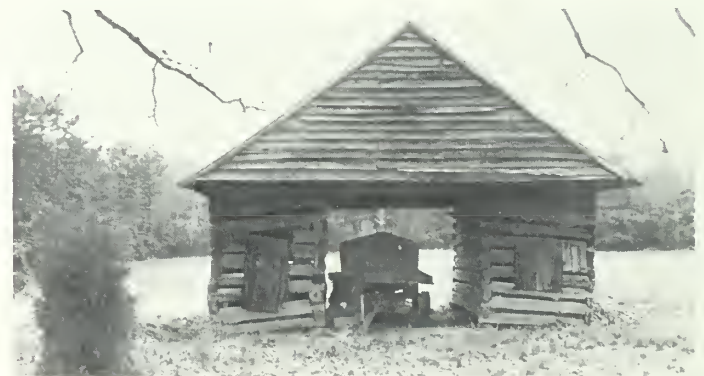
Fig. 3. This mid-19th century double-pen cornercrib on the Jamison Farm in Rowan County, North Carolina, is an example of a type of log building that did not require chinking. Photo: Denise Whitley.

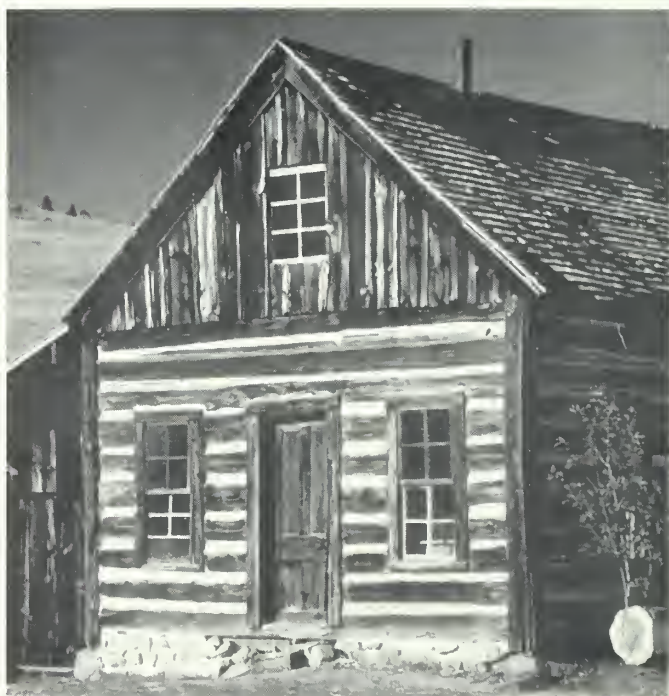
Fig. 9. This historic log building on the Walker Ranch in Boulder, Colorado is an example of the Rocky Mountain cabin form which is typified by the entrance door being located in the gable end. Photo: Bernard Weisgerber.

A somewhat different form evolved in the West around the middle of the 19th century which became especially distinctive of the Rocky Mountain cabin. While the entrance doorway to most earlier log houses was generally placed beneath the eaves, as a means of adapting to the greater snowfall in the Rockies, here the entrance was placed in the gable end, and sometimes protected from roof slides by a porch supported by two corner posts created by an extension of the roof beyond the gable wall (Fig. 9).

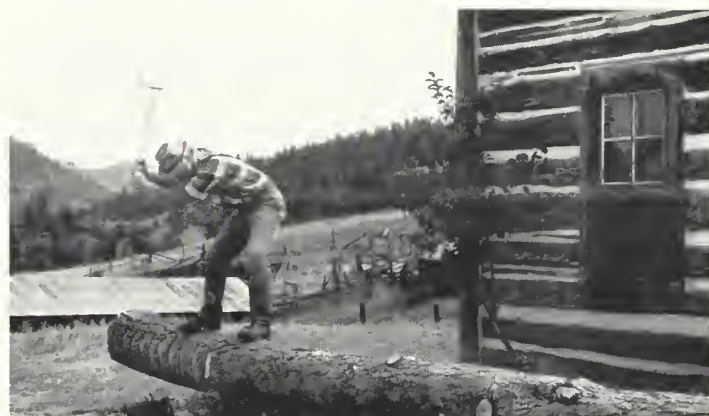
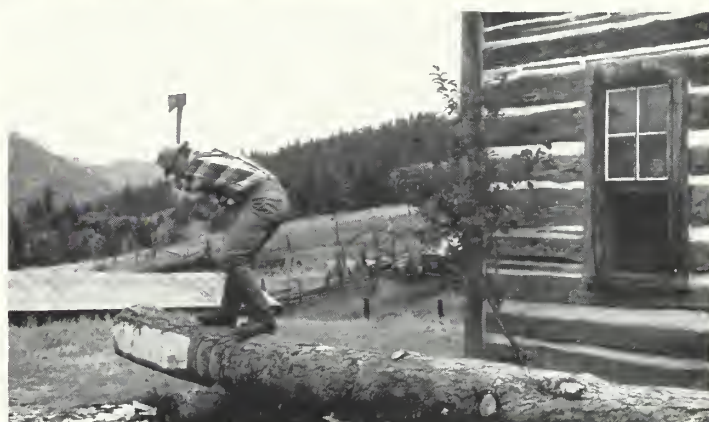
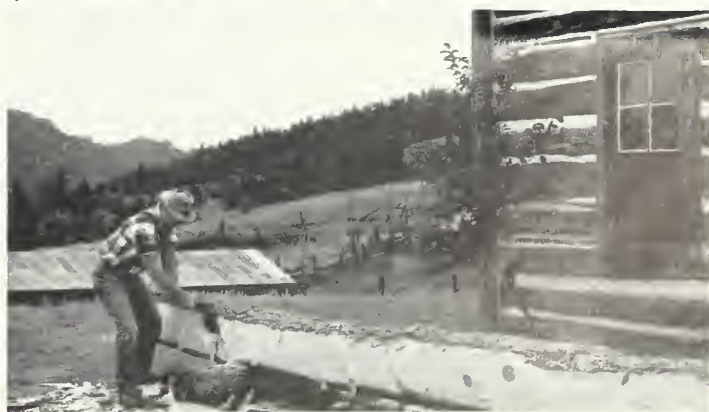
Fig. 11. Log-hewing tools and techniques: (a) scoring the log with a single-bladed felling axe, or "pole axe" in preparation for removing a uniform thickness of wood; (b) removal to depth of scoring; (c) finish hewing with a broad axe. Photos: Courtesy Bernard Weisgerber.

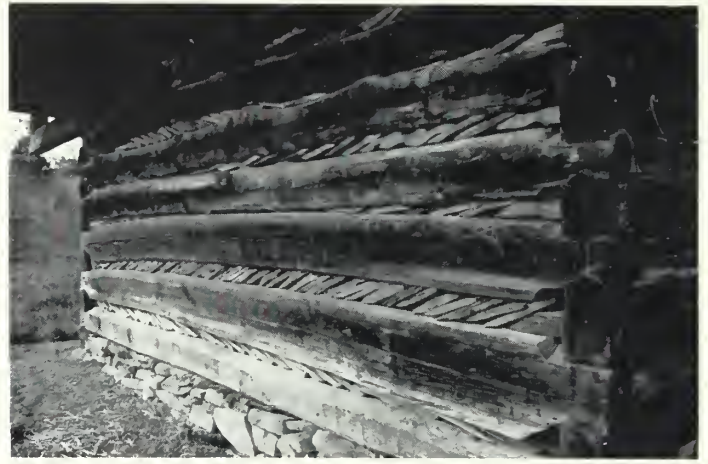
Fig. 12. The log joints have been cleaned out in preparation for new daubing exposing carefully laid stone chinking in this building in Virginia. Photo: Bernard Weisgerber.

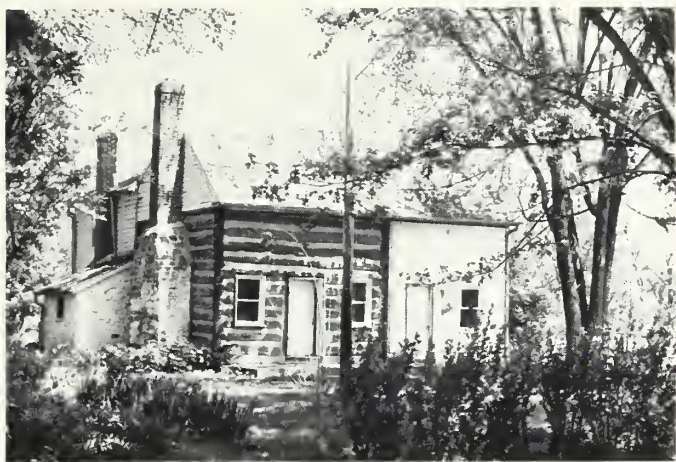
Fig. 13. Historic wood clapboard siding originally applied to conceal the fact that this house was built in two sections of different materials has been inappropriately removed from the 1793 log portion. Photo: National Park Service Files.

Sometimes log houses were sided or stuccoed later in an attempt to express a newly-achieved financial or social status. Many log houses were immediately sided and trimmed upon completion to disguise their simple construction beneath Georgian, Federal and later architectural styles. Frequently a log house was covered, or recovered, when a new addition was erected in order to harmonize the whole, especially if the original core and its addition were constructed of different materials such as log and wood frame (Fig. 13).

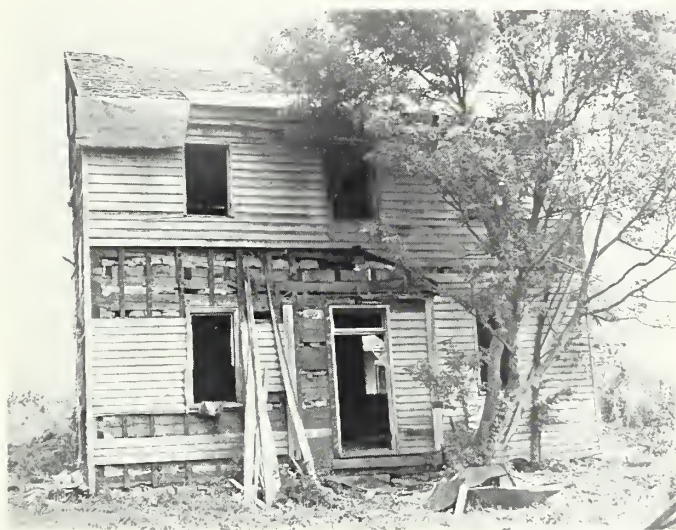
Fig. 14. Removal of the historic wood siding from the 1804 Zachariah Price DeWitt House in Butler County, Ohio, reveals that the clapboards were attached to vertical wood furring strips nailed to the logs. Photo: National Park Service Files.

Vertical wood furring strips were generally nailed to the logs prior to applying weatherboarding or stucco (Fig. 14). This ensured that the walls would be plumb, and provided a base on which to attach the clapboards, or on which to nail the wood lath for stucco.

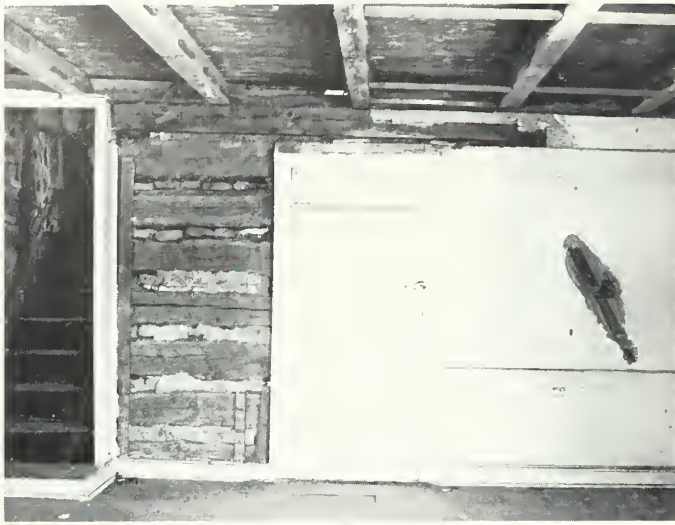
Fig. 16. This photograph of the interior of a 1793 log house in Maryland reveals much about historic log building construction and interior finish treatments. To the left of the plank door plaster has been removed exposing the stone chinking and danting; remnants of vertical furring strips attached to the logs show evidence of traditional horizontal lath, while the hole broken through the plaster wall on the right shows the use of diagonal lath. The open door reveals a very steep, enclosed stairway typical of many early log houses. Although plaster has been removed from the ceiling, the wall to the right of the door shows the original plaster finish and fine woodwork including beaded chair rail, floor and door molding. Photo: National Park Service Files.

Logs on the interiors of many of the simpler cabins and Rustic style structures were often given a flattened surface or left exposed. But, in the more finished log houses of the 18th and 19th century, they were more commonly covered for most of the same reasons that the exterior of the logs was covered—improved insulation, ease of maintenance, aesthetics, and keeping out vermin. Covering the interior log walls with planks, lath and plaster, boards pasted with newspaper, fabric such as muslin, or wallpaper increased their resistance to air infiltration and their insulation value. Finished walls could be cleaned and painted more easily, and plastered walls and ceilings obscured the rough log construction and prepared interior surfaces for decorative wood trim in the current styles (Fig. 16).

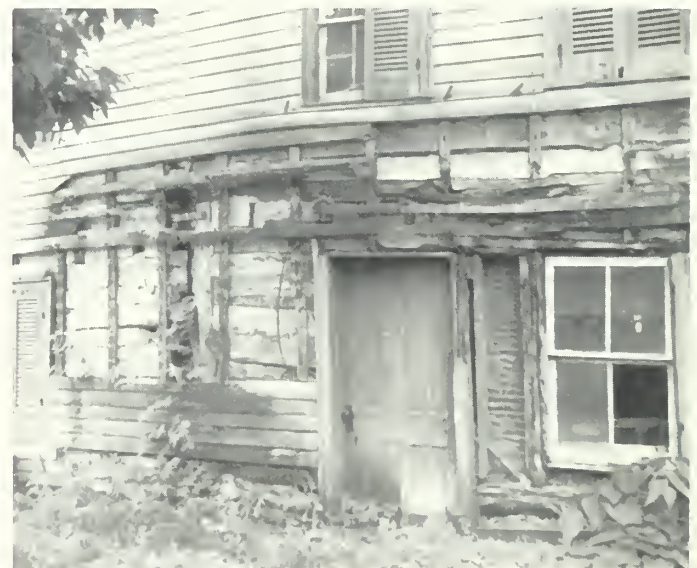
Fig. 17. Contact of this building's sill log with the ground has led to its decay, infestation by wood-destroying insects, and resulting building settlement. Photo: Anne Grimmer.

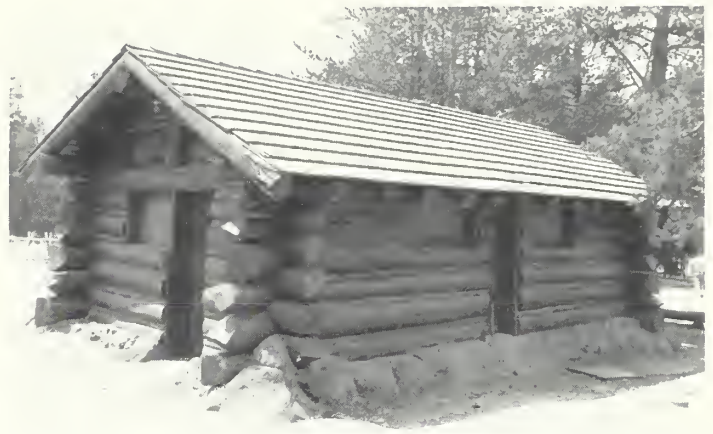
Fig. 18. Exposed roofing members of Rustic style buildings such as this structure at Yellowstone National Park are highly susceptible to deterioration. Photo: Laura Soulliere Harrison.

story was added, or repaired as the result of storm or fire damage. Often, roof framing may be composed of reused material recycled from earlier buildings. Inspection of the roof framing should note its configuration and condition. Typical problems to look for are framing members that have been dislodged from their sockets in the roof plate, or that are cracked, ridge damage, sagging rafters, broken ties and braces, and decay of exterior exposed rafter or purlin ends, especially common on Rustic style buildings (Fig. 18).

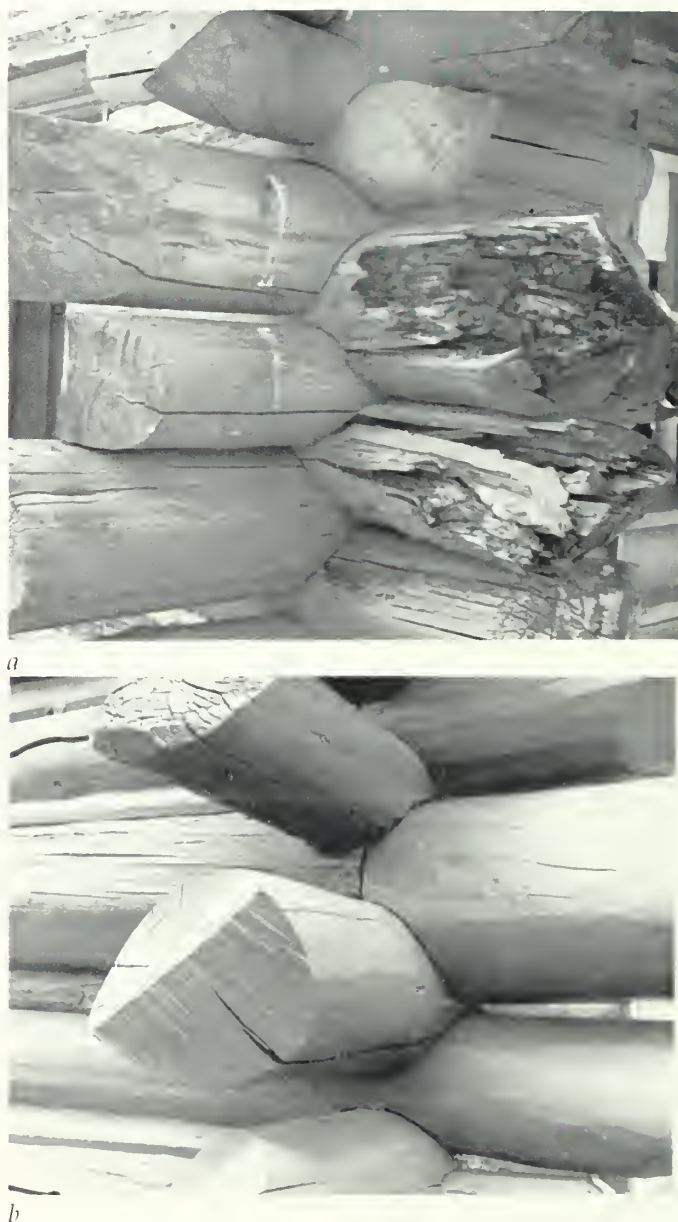
Fig. 20. (a) These deteriorated log crowns were (b) repaired with new crowns which were attached to the historic logs with reinforcing bars and epoxy. Epoxy repair of log crowns is most successful when the repaired crowns are protected from excess moisture by a roof overhang. Photos: Harrison Goodall.

The technique of treating, for an example, a decayed log crown with epoxies is begun by removing loose decayed wood, and drying the area if necessary (Fig. 20). The rot-affected cavity and surface of the log end is then saturated with liquid epoxy by repeated brushing, or by soaking it in a plastic bag filled with epoxy that is attached to the log. The porous condition of the rot-damaged wood will draw up the epoxy like a lamp wick. Once the liquid epoxy has saturated the log end and cured, the log end has been consolidated, and is ready for the application of an epoxy putty filler. The filler resin and hardener must also be mixed; pigments must be mixed with the filler epoxy to color the patch, and more importantly to protect it from ultraviolet sunlight. The filler can be applied with a putty knife, pressing it into the irregularities of the cavity. The cured patch can be worked like wood and painted with an opaque stain or a dull finish paint to help it blend with surrounding wood, although epoxy repairs can be difficult to disguise on natural, unpainted wood.

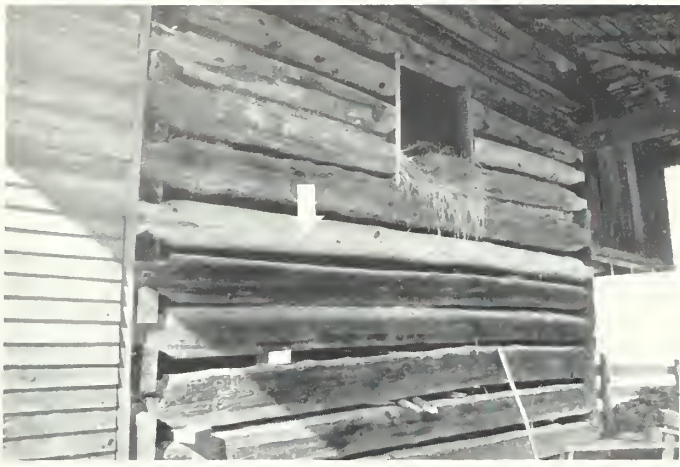
Fig. 22. The lighter-colored replacement log in this barn matches the dimensions and hewing marks of the original logs, and will darken in time to blend visually with the other logs. Photo: Bernard Weisgerber.

A replacement log should be obtained to match the wood species of the original being removed. If it is a hewn log, then the replacement must be hewn to replicate the dimensions and tool marks of the original (Fig. 22). If the same wood species cannot be obtained in the original dimensions, a substitute species may have to be used, and may even be preferable in some instances

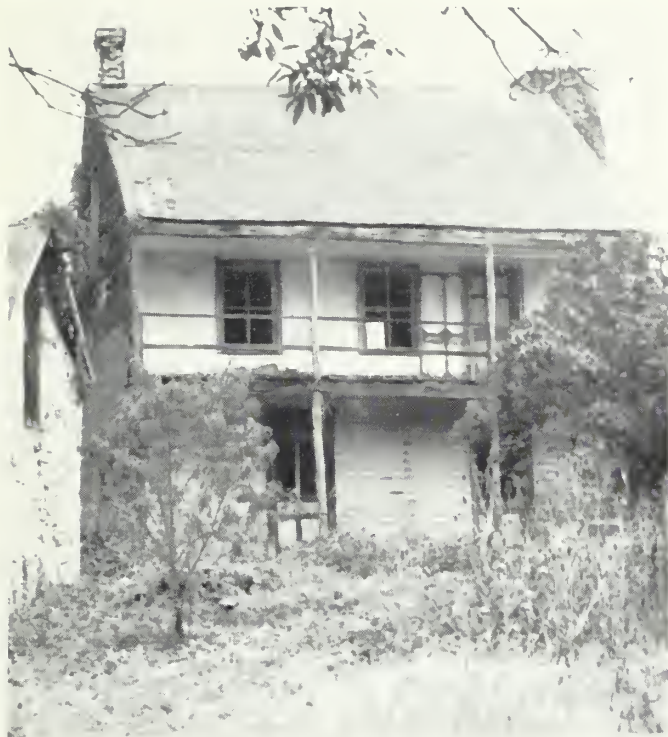
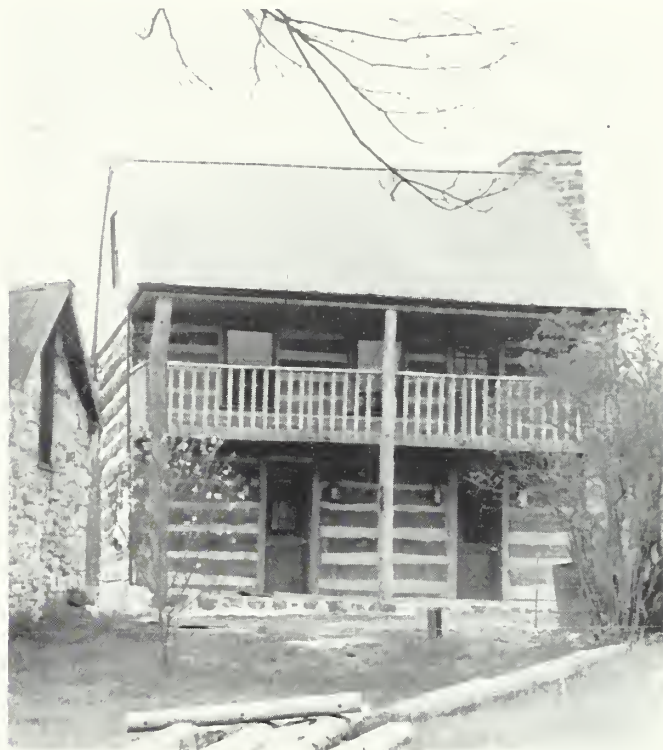
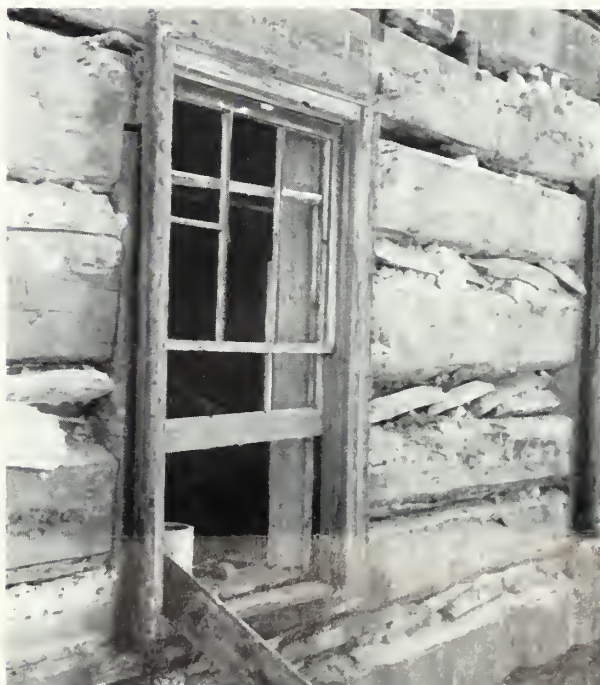
Fig. 25. (a) Prior to rehabilitation, the exterior of this late 18th century log house was sided with wood clapboard, which had been covered over by a later artificial siding, while the upper gallery of the second floor porch was stuccoed. (b) During the rehabilitation both the historic wood siding and stucco were removed to expose the logs, the gables were sided with wood shingles, and what would have originally been milled wood columns supporting the porch were replaced with rough, unmilled log posts. Collectively, these treatments diminished the building's architectural integrity, and gave it an appearance it never had. (c) The depth that the window frames extend out beyond the log surface allowing space for siding is an indication that cladding was part of the building's original construction. Photos: National Park Service Files.
